Manhole Inspection Summary

Manhole # S13WW1004MH

Insp Date: **10/2/06 10:04 AM**

Location Address: **5420 GREENSPRING AVE**

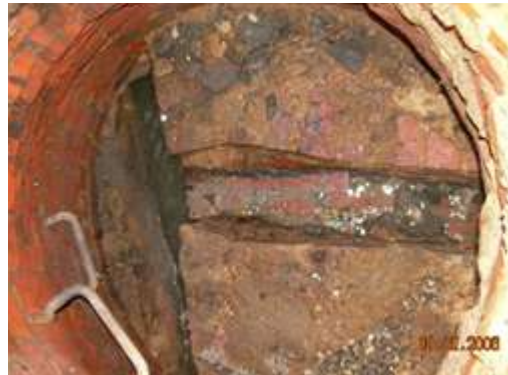
Top View

Infiltration: ☐ None ☐ Joint ☐ Cracks ☐ Mortar ☐ Roots ☒ **Wall**

Infiltration: ☐ None ☐ Joint ☐ Cracks ☒ **Mortar** ☐ Roots ☒ **Wall**

☐ Parged ☒ **Debris** (not Condition related)

☒ **Evidence Of Surcharge** Depth: **1** (ft.) ☐ Active Surcharge Present

Corbel and Barrel infiltration. Evidence of surcharge - Bench debris.

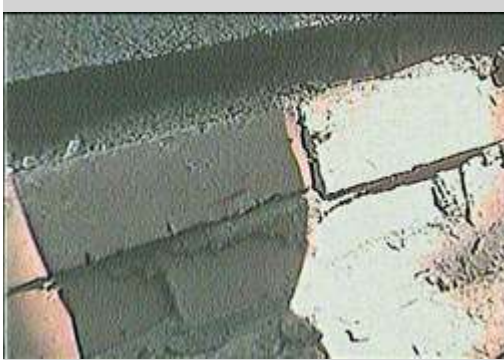
Defect

Condition: ☐ Sound ☐ Cracked ☐ Root Intrusion ☐ Loose Brick ☒ **Deteriorated**

Infiltration: ☐ None ☒ **Joint** ☐ Cracks ☒ **Mortar** ☐ Roots ☐ Wall

Adjustment deterioration and infiltration.

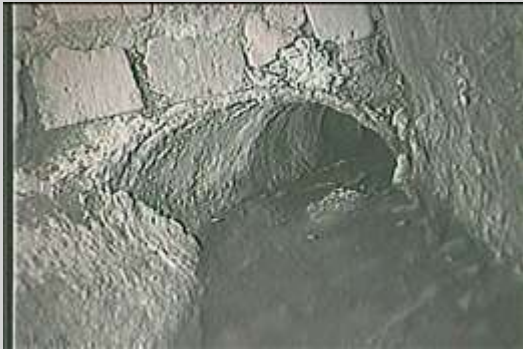
8 in. Circular Gravity Sewer Pipe Out @ 12 O'Clock

Deposits: ☐ None ☒ **Mud** ☐ Sludge ☒ **Debris** ☐ Grease

Silt Depth: **1** (in.) Deposits Extent: **Light**

Infiltration: **Evidence** Pipe Seal Cond: **Cracked**

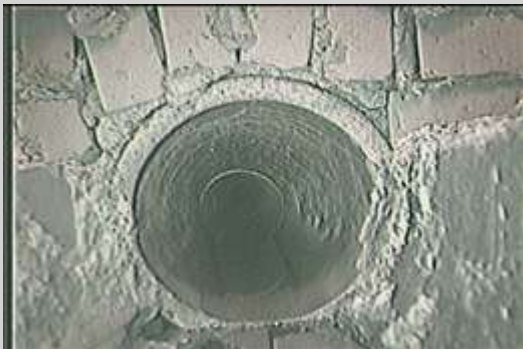
8 in. Circular Gravity Sewer Pipe In @ 4 O'Clock

Barrel deterioration.

Infiltration: **Evidence** Pipe Seal Cond: **Cracked**

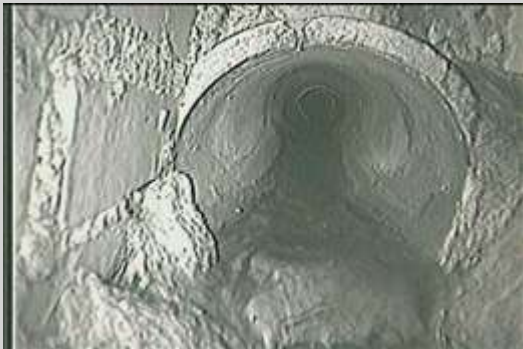
8 in. Circular Gravity Sewer
Pipe In @ 6 O'Clock

Infiltration: **Evidence** Pipe Seal Cond: **Cracked**
